Kingpin Maintenance and Replacement Recommendations

July 8, 1994

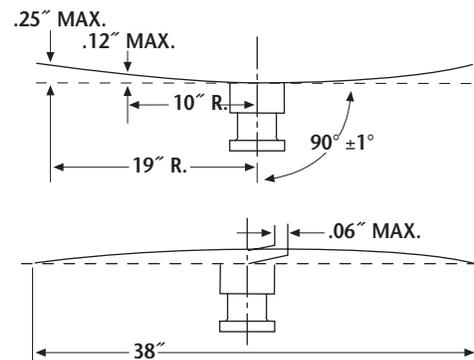
FIGURE 1

Using a 48" straight edge, check the flatness in all directions. Any bumps, valleys or warping will cause uneven loading of the fifth wheel, which could result in damage to the top plate and poor lock life. Replace the trailer upper coupler plate if flatness exceeds the specifications shown in *Figure 1*.

Using a square or Holland Kingpin Gage (TF-0110) check to see if the kingpin is bent. A bent kingpin accelerates lock wear and may interfere with proper fifth wheel locking. This also may indicate damage. The kingpin should be replaced if it exceeds 1° from square in any direction (see *Figure 1*).

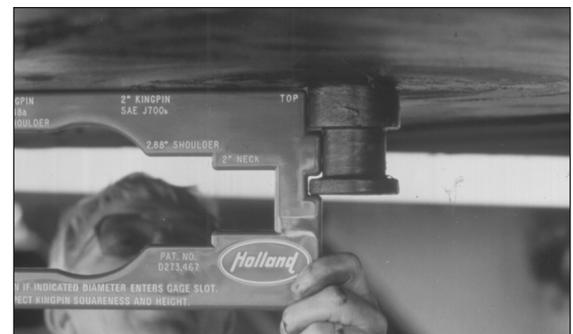
FIGURE 2

Using a Holland Kingpin Gage, check the length as shown in *Figure 2*.

If a lube plate is used in your operation, make sure to check the kingpin length. The kingpin must be sized to compensate for the thickness of the lube plate.

Holland Service Bulletin XL-SB4. Otherwise, the kingpin will be too short. If the kingpin length is improper, the kingpin should be replaced.

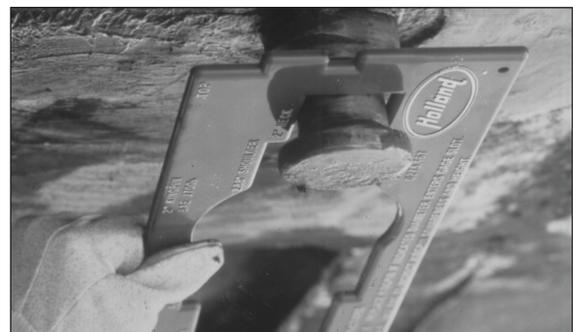
FIGURE 3

Using a Holland Kingpin Gage, check the wear on both the 2" and 2.88" diameters. Wear of 1/8" (.13") is indicated if the appropriate diameter enters the gage slot. Replace the kingpin if the gage slides into the appropriate gage slot (see *Figure 3*).

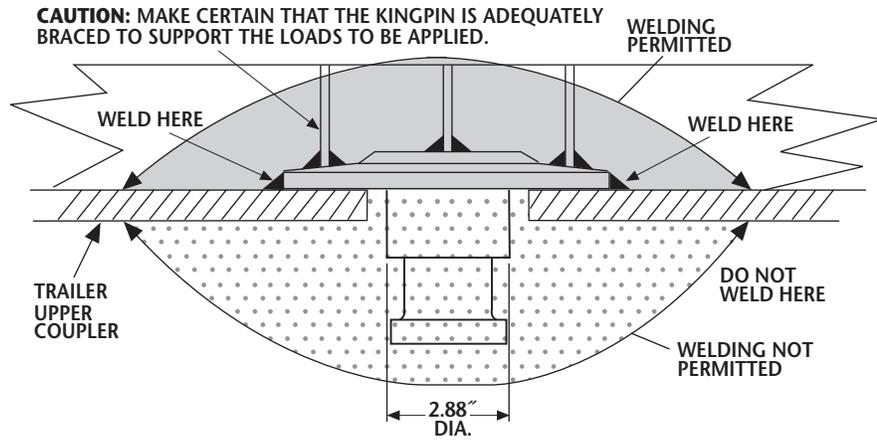
FIGURE 4

Kingpins are made from quenched and tempered alloy steel. Weld repairs of any type will affect the strength and wear resistance of the kingpin. Additionally, arc strikes or weld craters could develop a stress riser, leading to a fatigue failure. For these reasons, Holland warns against any weld repairs. If any deficiencies are noted during kingpin inspection, the kingpin should be replaced (see *Figure 4*).

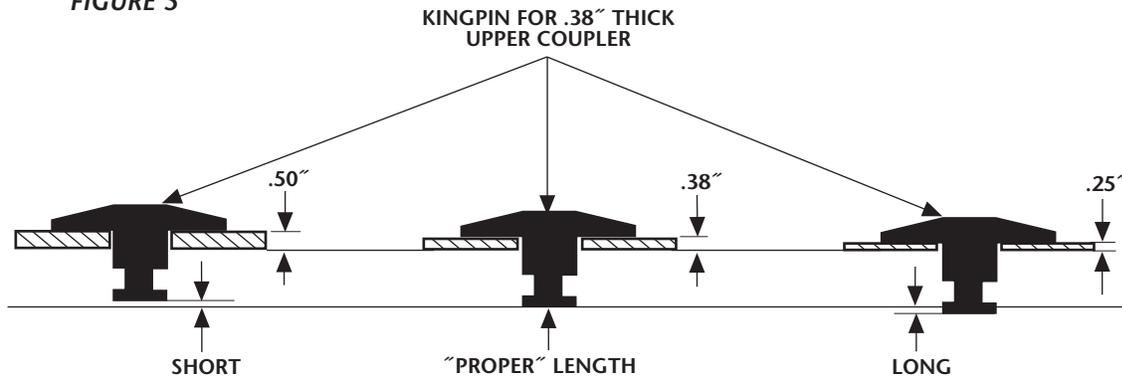
FIGURE 5

1. A kingpin should be selected which is similar to the type removed, or if of a different style, one which can be adequately braced. The kingpin must also be matched to the thickness of the upper coupler to maintain the SAE dimensions. Kingpins are manufactured in different lengths to match the thickness of the upper coupler. Improper selection will result in a kingpin that is too long or too short. See *Figure 5*.
